HINZE DAM STAGE 3 PROJECT Drainage Gallery Diamond Core Drilling

DRAINAGE GALLERY BREIF

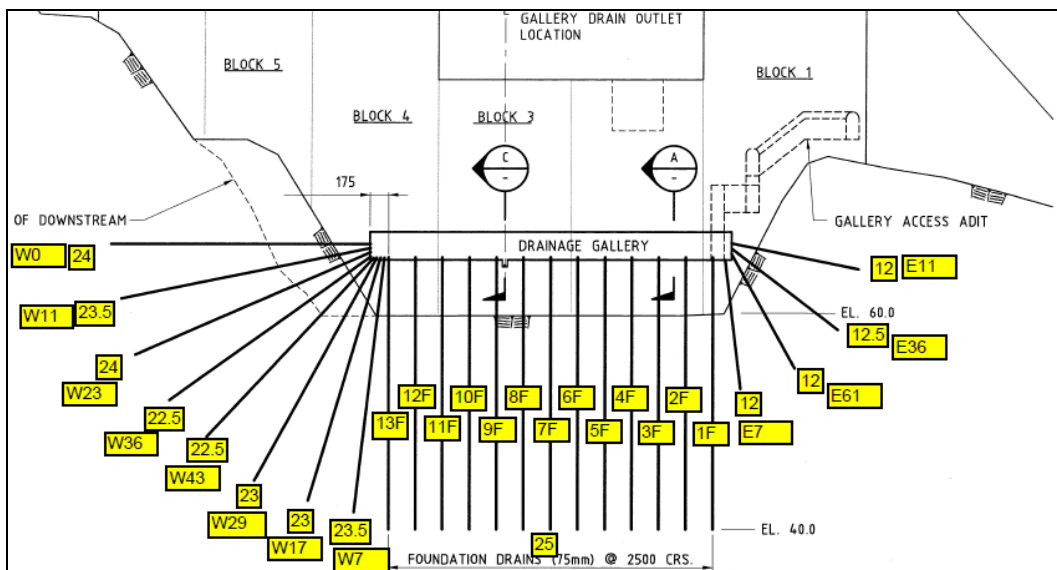
The existing drainage gallery is a cavity deep in the spillway wall and measures 2.5m high by 1.2m long by 35m wide. It is accessible via a number of flights of stairs from the upper portion of the spillway, see figure 1. The purpose of this gallery was to capture leaks in the construction joints of the spillway and monitor how the dam was behaving over time.

Figure 1 – Drainage Gallery Elevation showing Hole Depths and Numbering System

The stage 3 upgrade will share a modified version of the stage 2 gallery. To ensure that the increased hydrostatic pressures generated by the elevated height of the wall are controlled a number of pressure relief holes up to 25meters deep were to be cored in various areas of the gallery floor and walls.

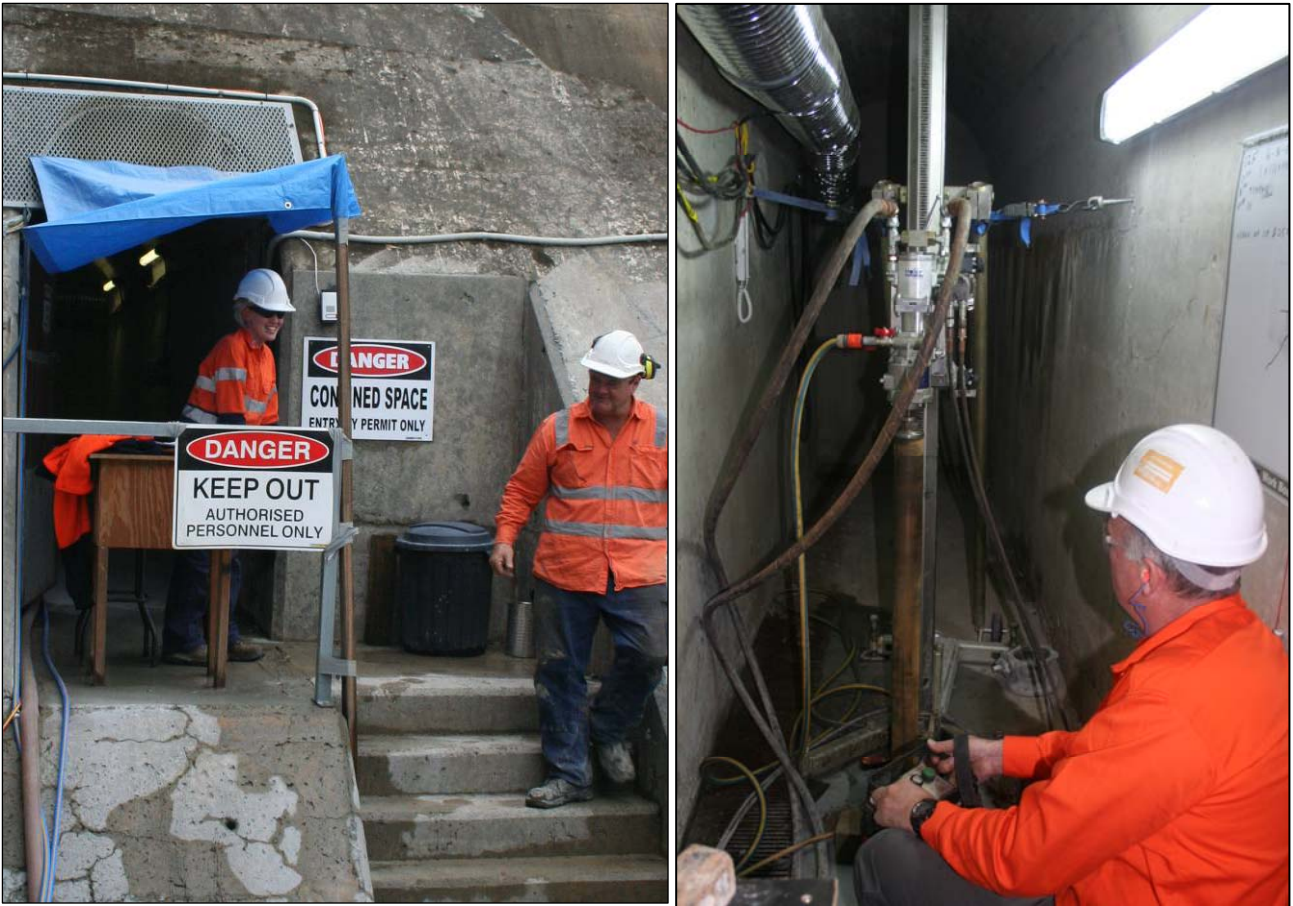
To work in a confined space all DecoTEC operators were to be confined space trained. In addition to this a spotter who was also confined space trained was to stand at the gallery entrance at all times in case of an emergency. Pneumatic powered ventilation fans, 4 point intercom system and fixed gas monitors were also installed to provided the operators with the safest possible working environment.

The required drilling equipment could not generate exhaust fumes in the enclosed area therefore hydraulic drilling gear was chosen to complete the work. This gear was exhaust free, quiet and provided powerful and efficient cutting conditions.

*Figure 2 – Left: Entrance to the Spillway Drainage Gallery
Right: Hydraulic Drilling Equipment*

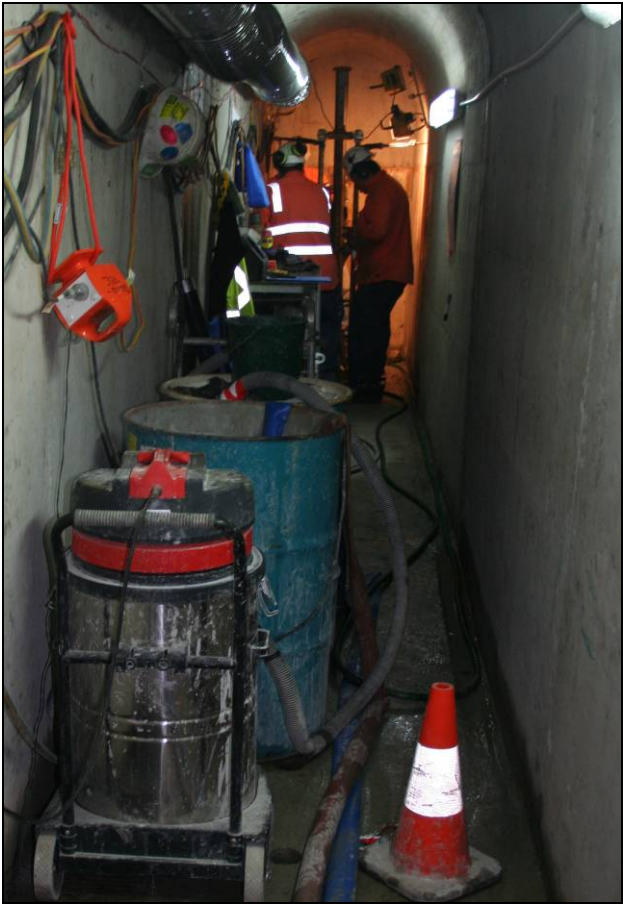
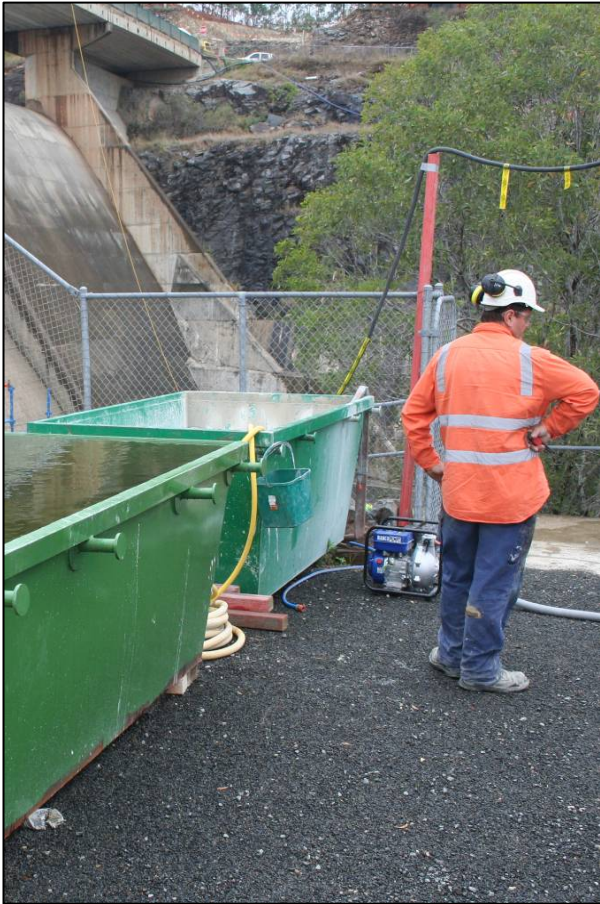
To ensure these works did not negatively impact on the environment all slurry generated needed to be treated for pH and disposed of in the site sediment basin. To tackle this problem DecoTEC setup an innovative slurry control system. This system consisted of a wet-vac continuously sucking in a collection pit. The wet-vac's factory tank was modified to expel the slurry into a 205 litre tank to reduce the need to attend to the slurry system. Once full these tanks were swapped out for an empty tank whilst the full ones were being stage pumped into a 3kL bin located adjacent to the gallery entrance. The slurry in this bin was then treated for pH and, with the aid of flocculent, left to settle before disposing of in the sediment basin.

Water was provided to core drills via a 3kL tank and a fire pump located outside the gallery.

*Figure 3 – Left: Gallery Floor Slurry Control System
Right: Slurry Collection Tank and Water Supply Tank*

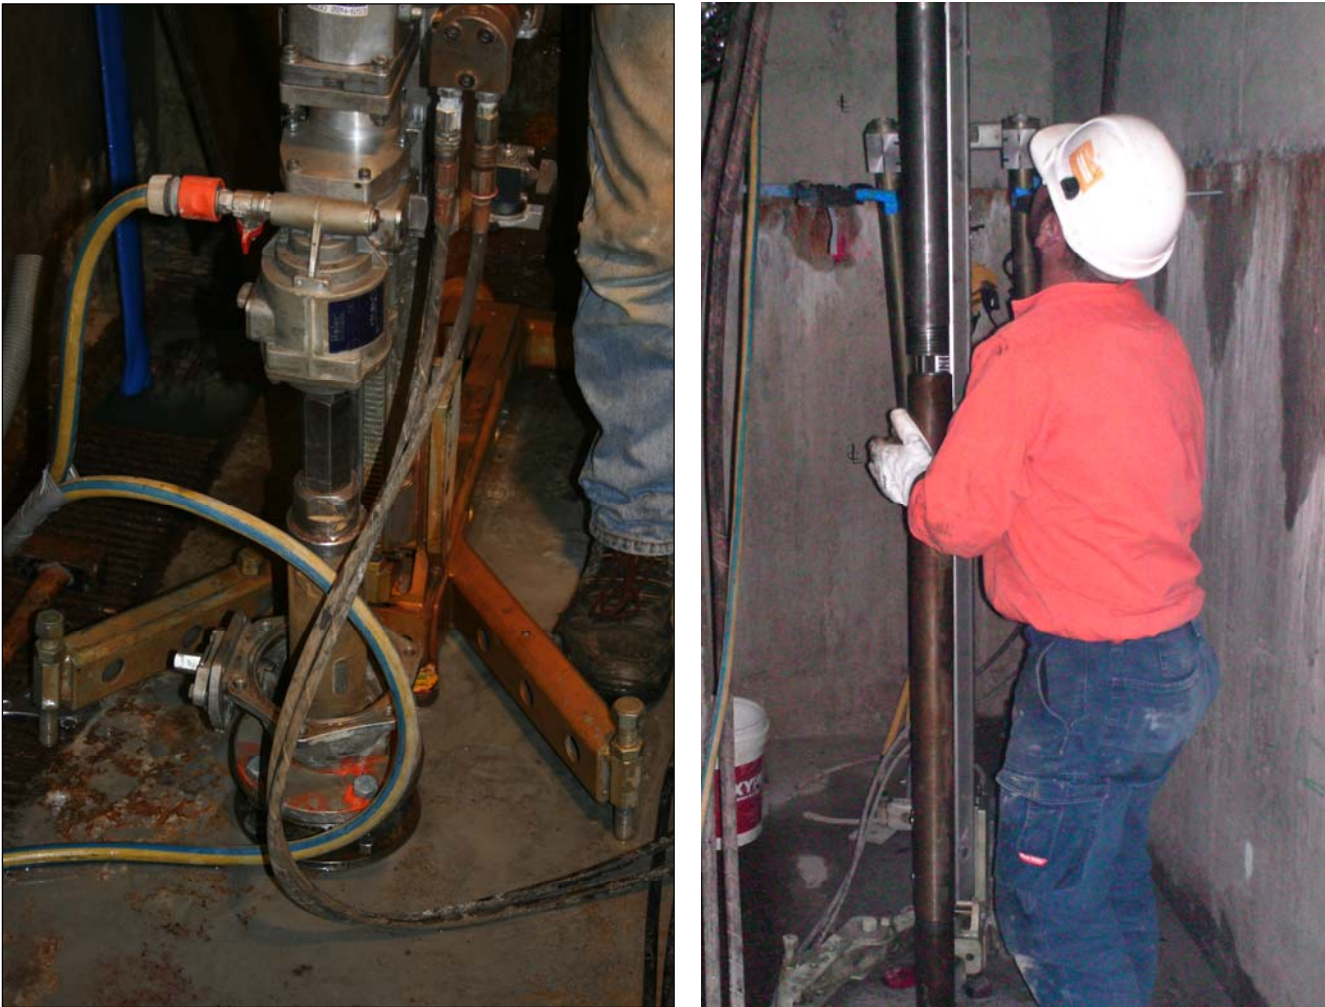
Figure 4 – Drilling Equipment

To core to the required angles and depths within an extremely small margin of error diamond core drilling was chosen to carry out the works. To stay within the clients' program two drill rigs with specially fabricated diamond core cutting heads were used. These cutter heads provided a precision cut to the desired diameter whilst maintaining the required production rates.

Due to the tight fit inside the gallery 1metre screw type core barrels were used. Every metre of cutting required a new barrel to be screwed onto the chain. To ensure the holes would stay on line with how they were initially setup reamers were used. Several of these were installed throughout the chain of barrels and provided the barrels with a tight fit inside the hole.

At the time of coring there was up to 15 meters of head in the dam. This therefore created the potential for water to backflow out of the cored holes generating a safety hazard. Even though the calculated maximum backflow pressure was only minimal DecoTEC wanted to ensure the uttermost safety for their operators therefore a backflow valve was fabricated and installed on each hole.

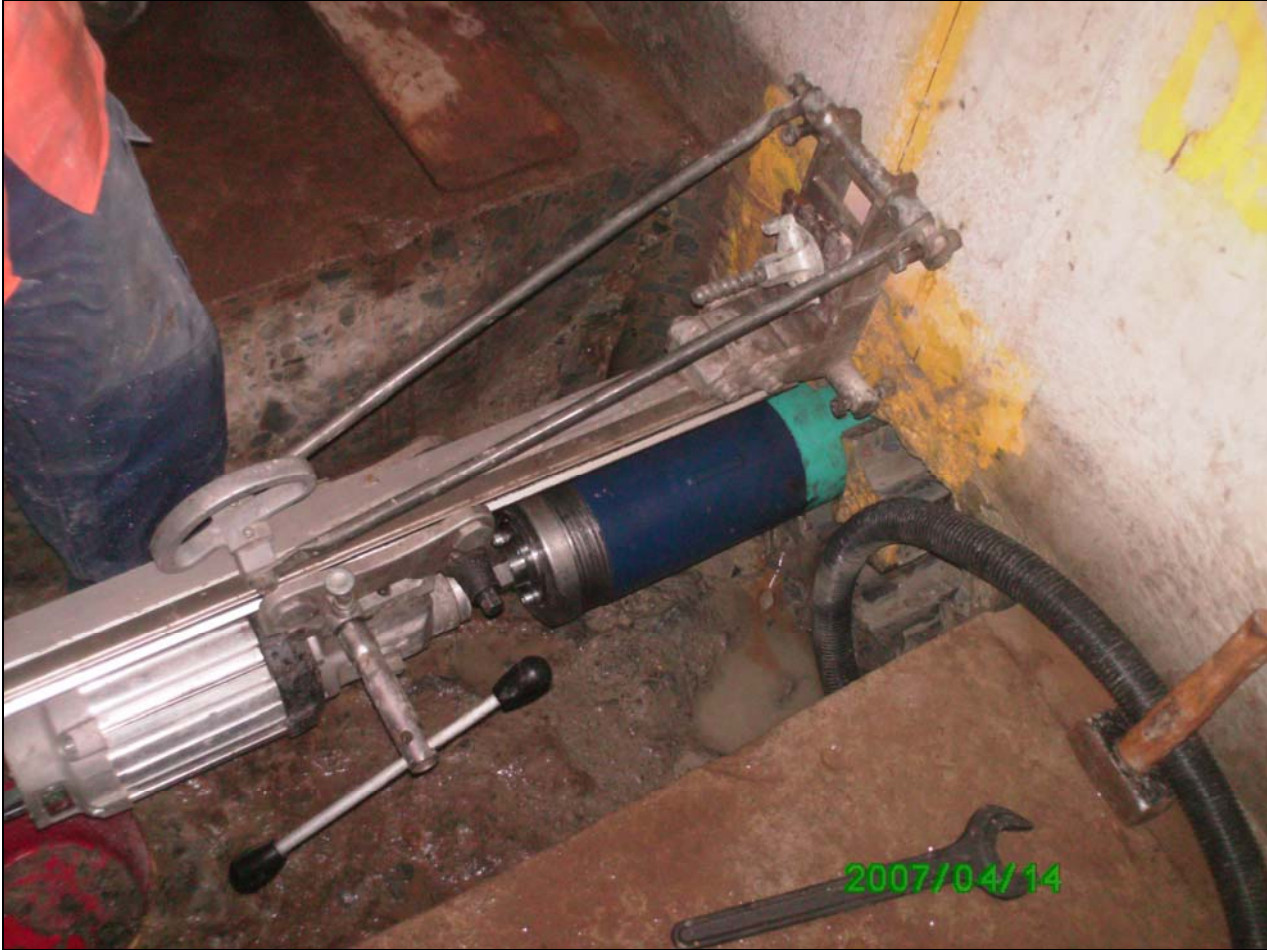
The horizontal outbound drain hole measured 160mm in diameter and was located below the floor of the gallery. This required a cavity in the gallery floor and a recess in the downstream gallery wall to be cut out to make room for the drilling gear. Along with this tight fit DecoTEC also had to ensure that the appropriate fall was maintained along the entire 18metre length of the hole.

Figure 5 – 160mm Diameter Drain Hole
