DecoTEC Installs Waterway Barrier System in Urrea Dam, South America

Client:	EMPRESA URRA S.A. E.S.P.
Location:	Urrea Dam, Colombia, South America
Project:	Urrea Dam Debris Barrier Installation

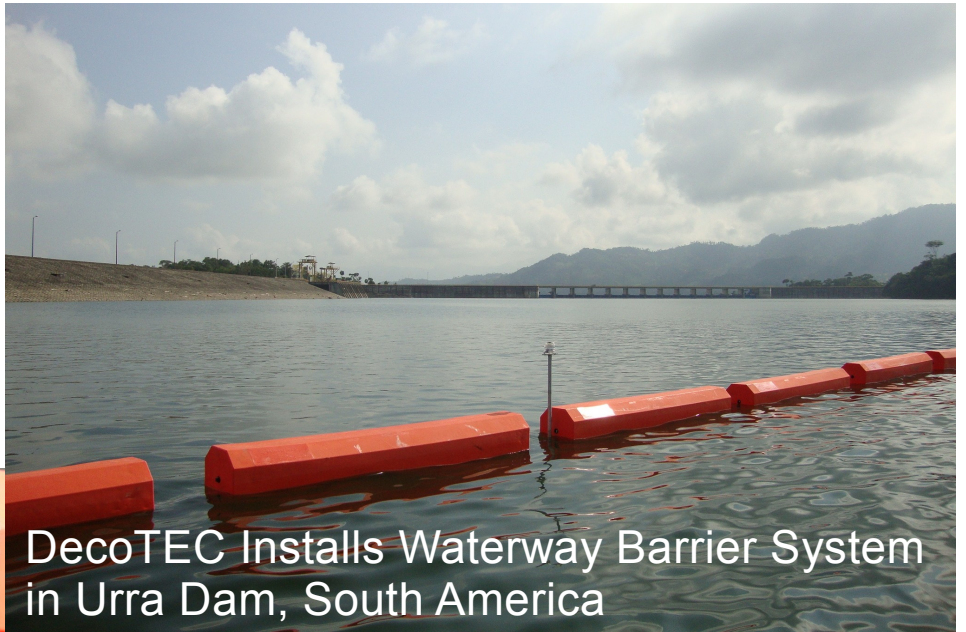
The barrier measures 600ms from shore anchor to shore anchor. To account for the rise and fall in the lake level which can be up to 20ms, 220 x 3m long booms were ordered. A 60mm deep fence, each piece being 3.2ms to allow for a 100mm overlap at either end, was manufactured in Colombia and these were hung off each buoy.

At the centre of the boom, an in-line anchor and an adjacent gate were installed to give access to the boats that clear away the debris.

Because the lake is accessible to the public and there is night fishing, solar-charge flashing lights which can be seen from a range of 1.8kms were installed at about 50m intervals. The buoys are made of UV resistant polyester, are impact

resistant and unsinkable. They have a steel structural member which the buoy is moulded around.
